INSTALLATION RESTORATION PROGRAM PHASE II - CONFIRMATION/QUANTIFICATION STAGE 2

. FINAL REPORT

HANCOCK FIELD SYRACUSE, NEW YORK 13211-7099

JUNE 1989

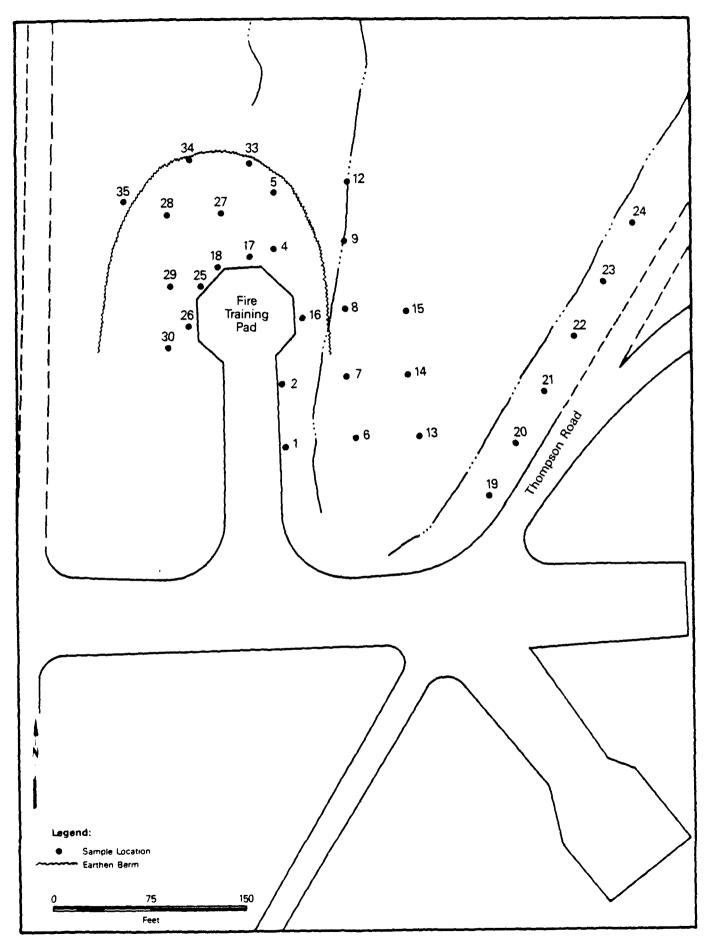
Figure 3-1. Soil Gas Sampling Stations at FT-1

The analytical results show that none of the volatile compounds detected in the soil gas survey were found in the soil samples. In fact, no volatiles were detected in soil during the initial sampling round in November 1986 nor during the resampling in August 1988. It is possible that volatiles were in the soils in 1986 and were not detected due to laboratory error. It is also possible that by 1988, the compounds detected in the soil gas had had sufficient time to volatilize. A more likely possibility is that small amounts of fuel seeped through the joints in the concrete hardstand during fire training activities and contributed volatiles to the soil vapor around the margins of the hardstand. In any case, soil gas was the only media where volatile organics were found, and they do not pose an unacceptable risk.

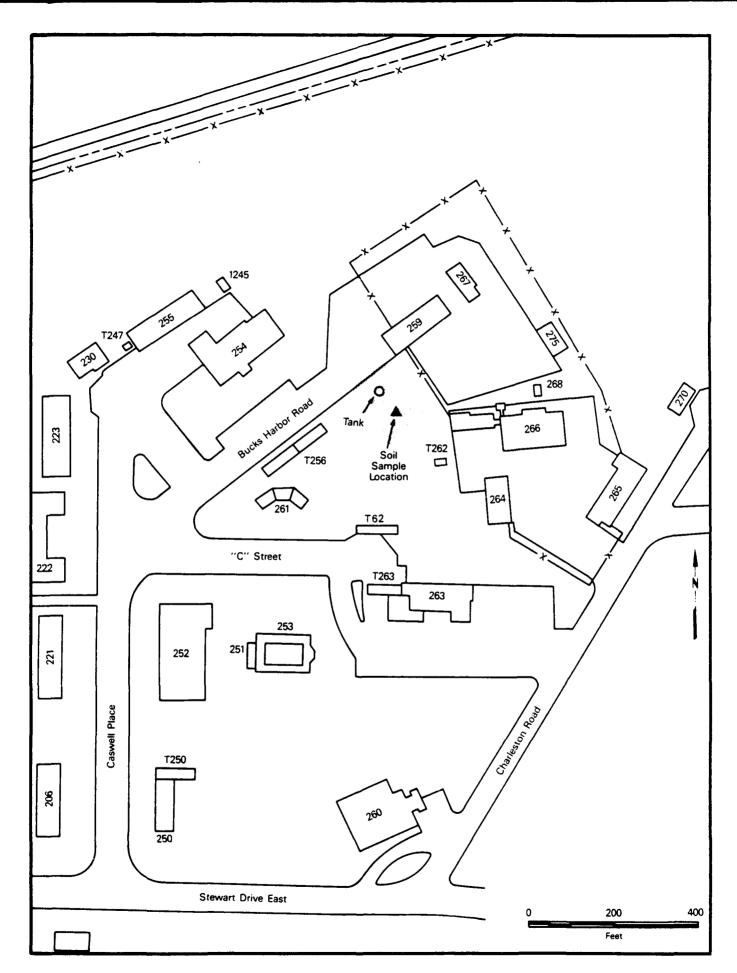
Figure 4-15. Entomology Underground Storage Tank Site S-3

pesticide containers were triple rinsed prior to disposal by the Defense Property Disposal Office (DPDO) (Zimmerman 1987). Given these dates, it is likely that the two insecticides detected in the tank are residuals from past entomology shop operations.

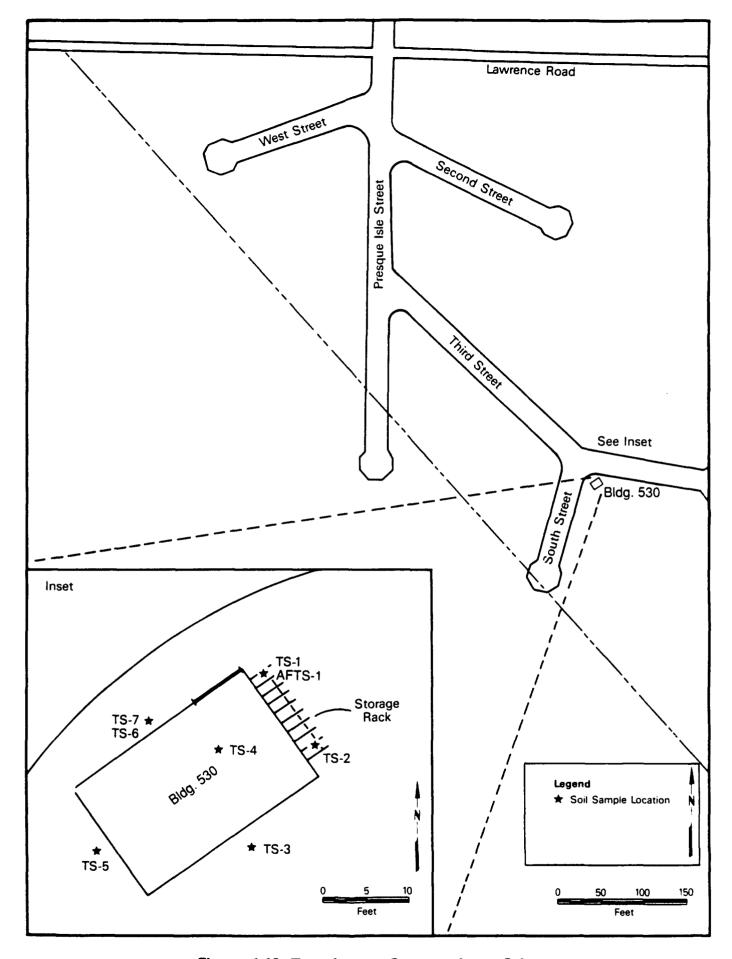
Figure 4-16. Transformer Storage Area, S-1

The six soil samples and one duplicate were analyzed for seven specific arochlors (PCBs). Only one sample (TS-2) contained detectable amounts (0.098 mg/Kg) of one aroclor (1260). No Federal criteria or standards for the protection of human health have been developed for PCBs in soil. A level of 50 mg/Kg PCB has been established under the Toxic Substances Control Act (TSCA) in determining whether PCB-containing waste or soils should be treated as hazardous. The concentrations observed in the single contaminated sample (TS-2) at Site S-1 are approximately three orders of magnitude below the 50 mg/Kg TSCA guideline. The TSCA guideline, however, is not adequate for evaluating the potential health risks associated with exposure to PCBcontaminated soils. Toxicity measures are not available for use in evaluating the potential for noncarcinogenic or carcinogenic effects following inhalation exposure (i.e., carcinogenic potency factors or acceptable intake values have not been developed for inhalation exposure to PCBs) (USEPA 1986). Therefore, the risk characterization for this site is based on potential ingestion of PCB-contaminated soil following the methodology presented in Section 4.4.5. The results of this risk characterization are shown in Table 4-27.

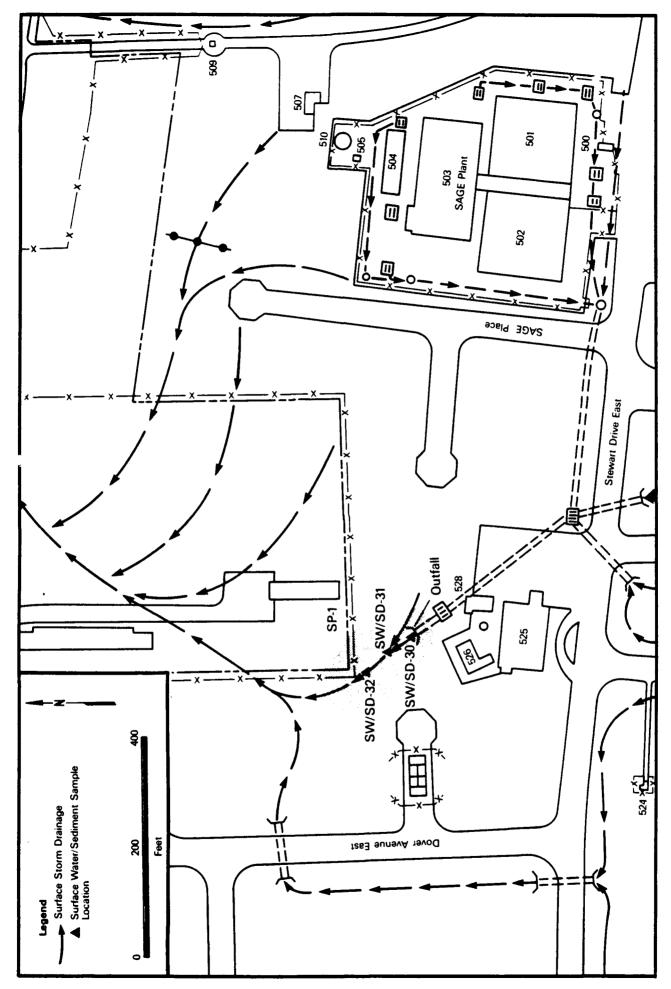
Figure 4-17. Old Spill Site, SP-1

Site SP-1 is a storm sewer outfall that drains surface water from the vicinity of the Semi-Automatic Ground Environment (SAGE) plant. This system is tied into a series of floor drains in Building 503, which is part of the SAGE plant complex, as shown in Figure 4-17. According to the base caretaker, discharges of fuel oil to the storm sewer occurred in the past when sump pumps in the Building 503 floor drains were set on automatic when an oil spill occurred in the building. Instead of the sumps being monitored and the fuel being pumped to an oil/water separator, the fuel automatically and mistakenly was pumped directly to the storm sewer. During the initial visit to this site

in September 1986, no visible signs of contamination were evident. When the samples were collected in early December 1986, it was discovered that base facilities personnel had erected a new gravel silt trap and three hardware cloth and straw filters across the stream just below the outfall. As a result of this construction activity, the stream banks had been reworked and oil sheens were visible when bank sediments were disturbed.
